Investigation of failures of a high-speed crankshaft.

Lindgren, George B.

Monterey, California: U.S. Naval Postgraduate School

George Bjorn Lindgren
Lieutenant, United States Navy

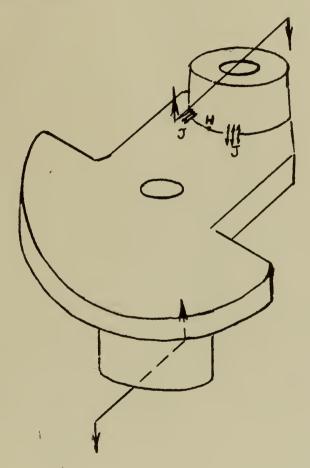
Fig. 4 Location of Critical Bending Stresses

The nature of these concentrations depend in a large measure upon whether or not lightening holes are present. If journals and pins are solid, stress reaches a maximum at the center, point H, Fig. 4; but if they are bored the stress at the center recedes and a pair of peaks JJ are formed.

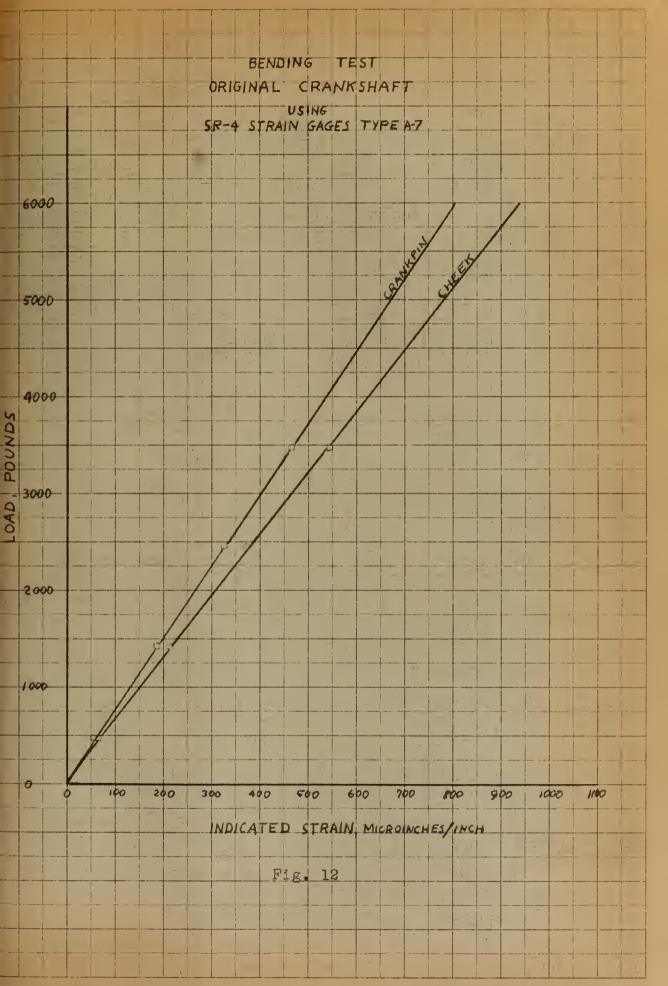
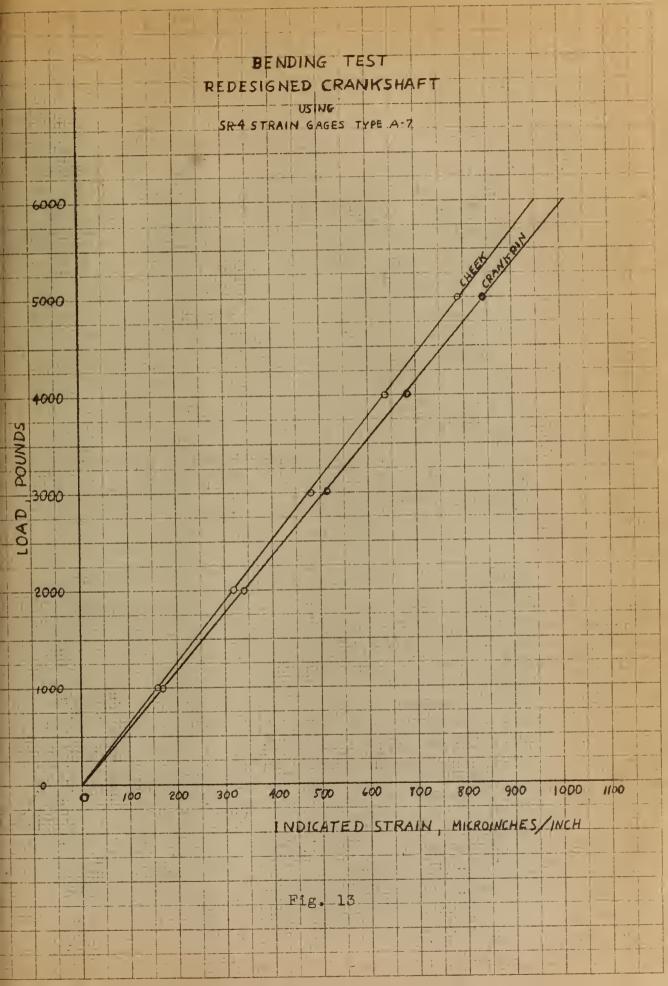
It is interesting to note on Fig. 12 and 13 that the load vs strain plot for the cheeks on both the original and new crank sections practically coincide, while the slope of the load vs strain curve for the crankpin of the redesigned section has been decreased, indicating that the strain level has been raised in the new design.

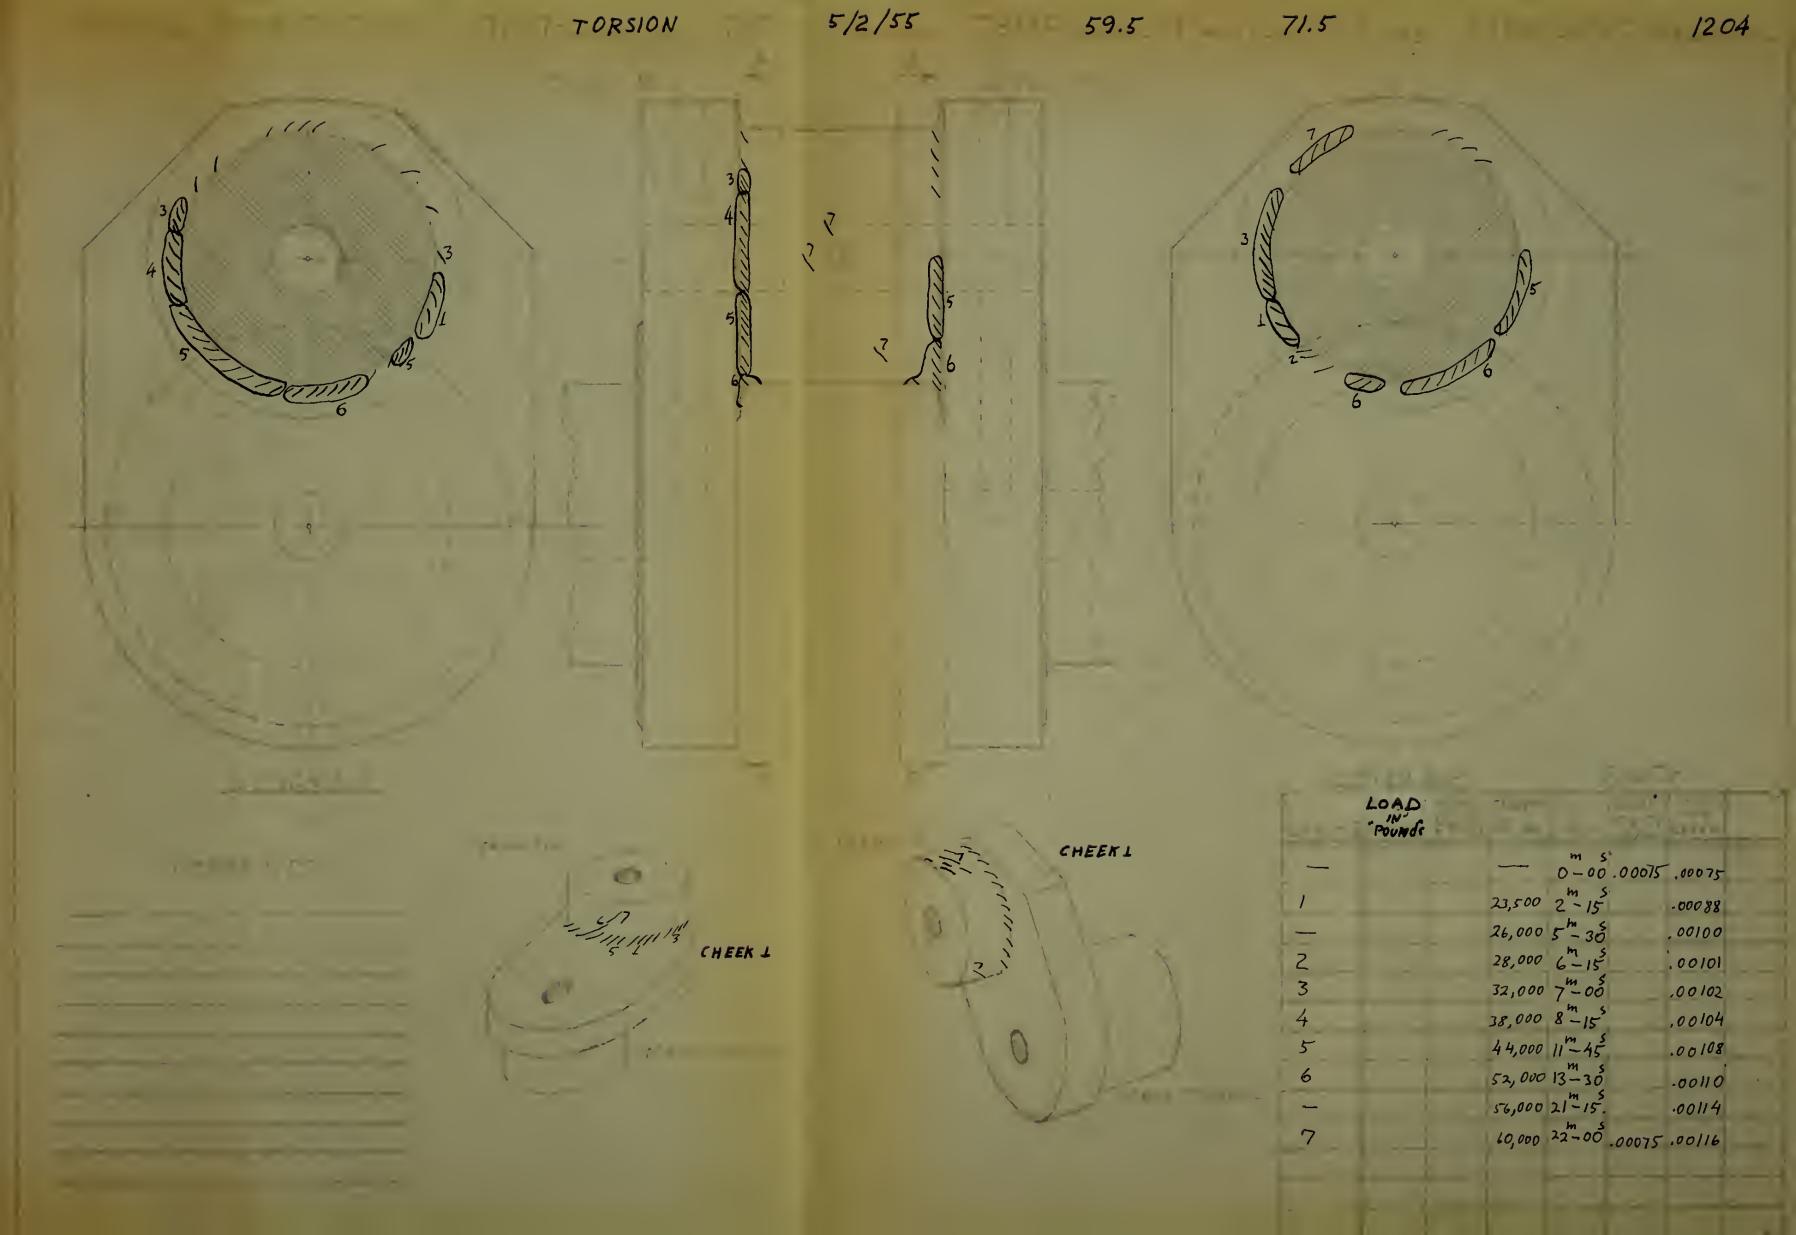
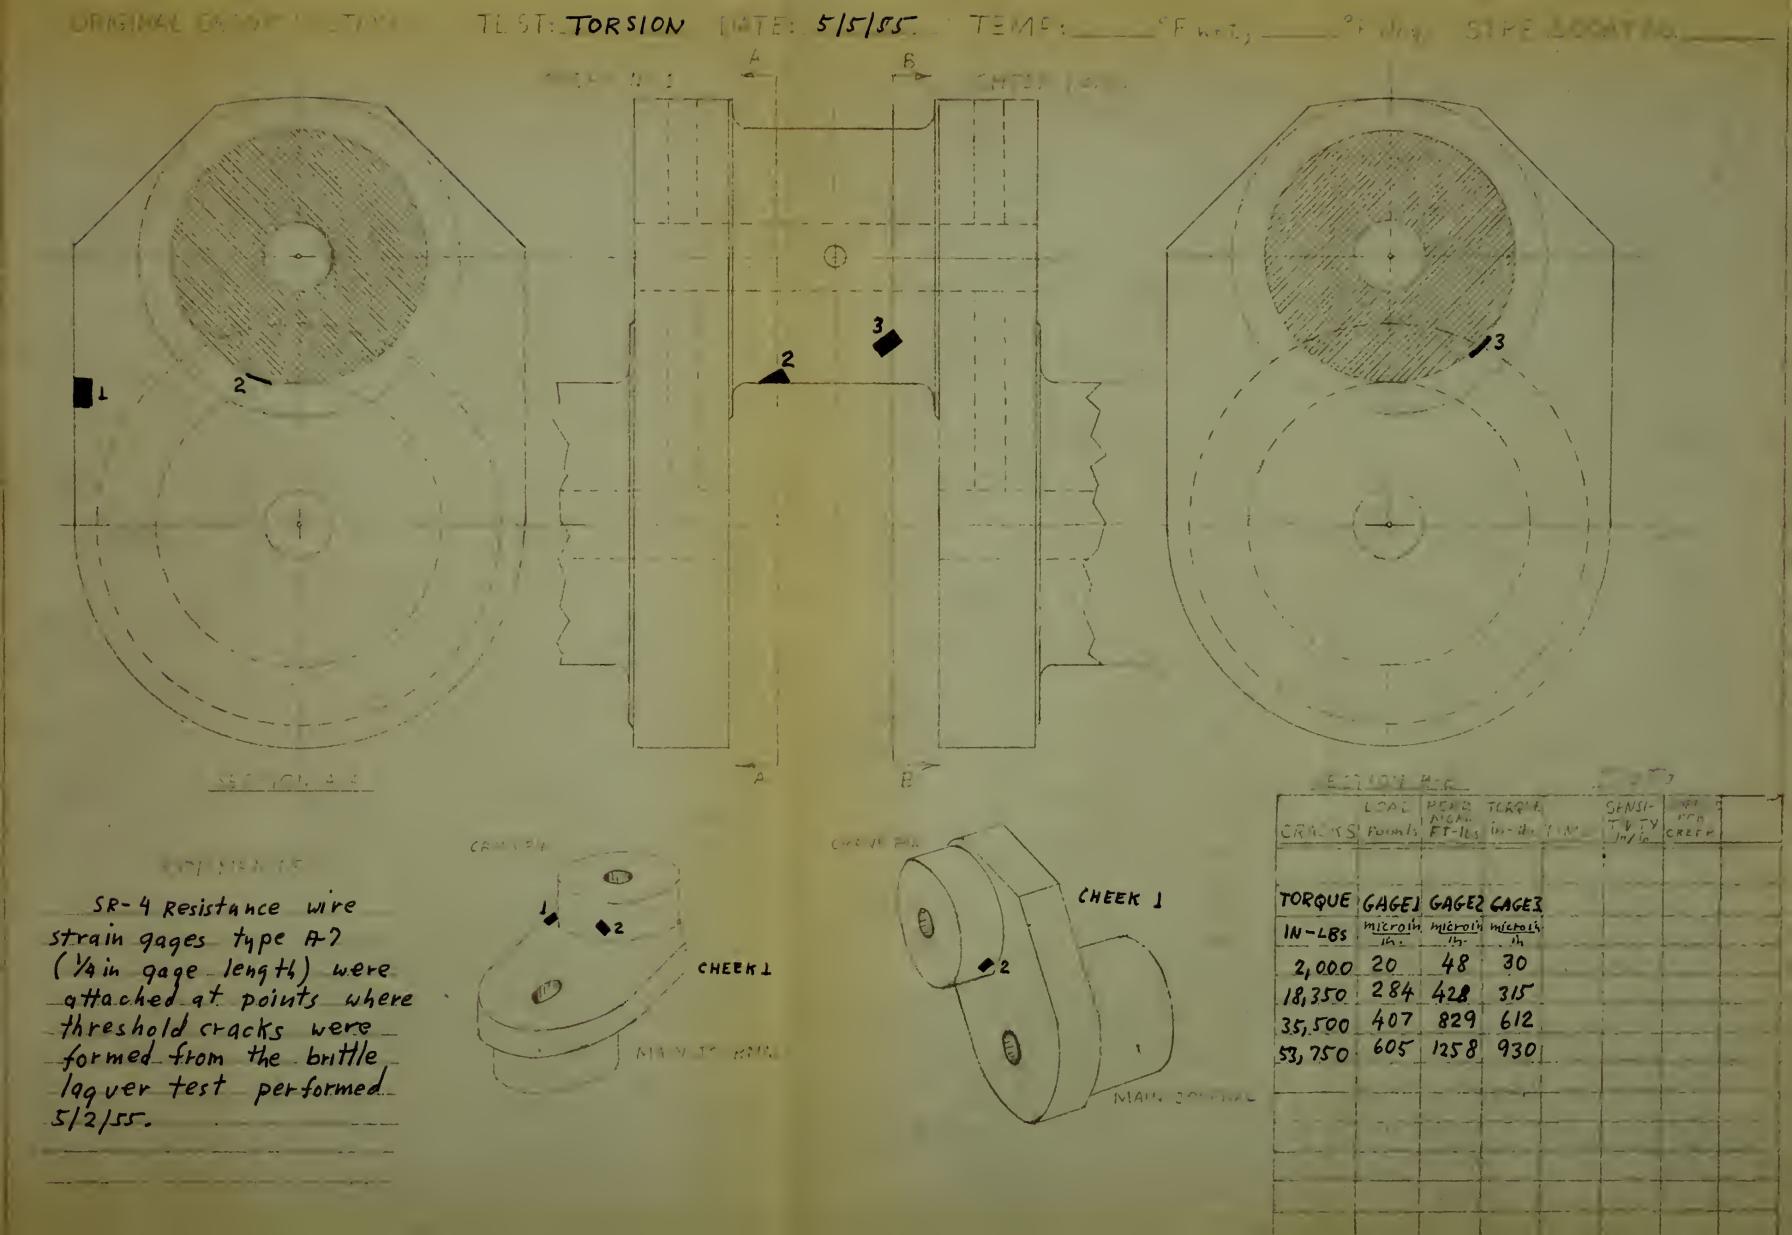
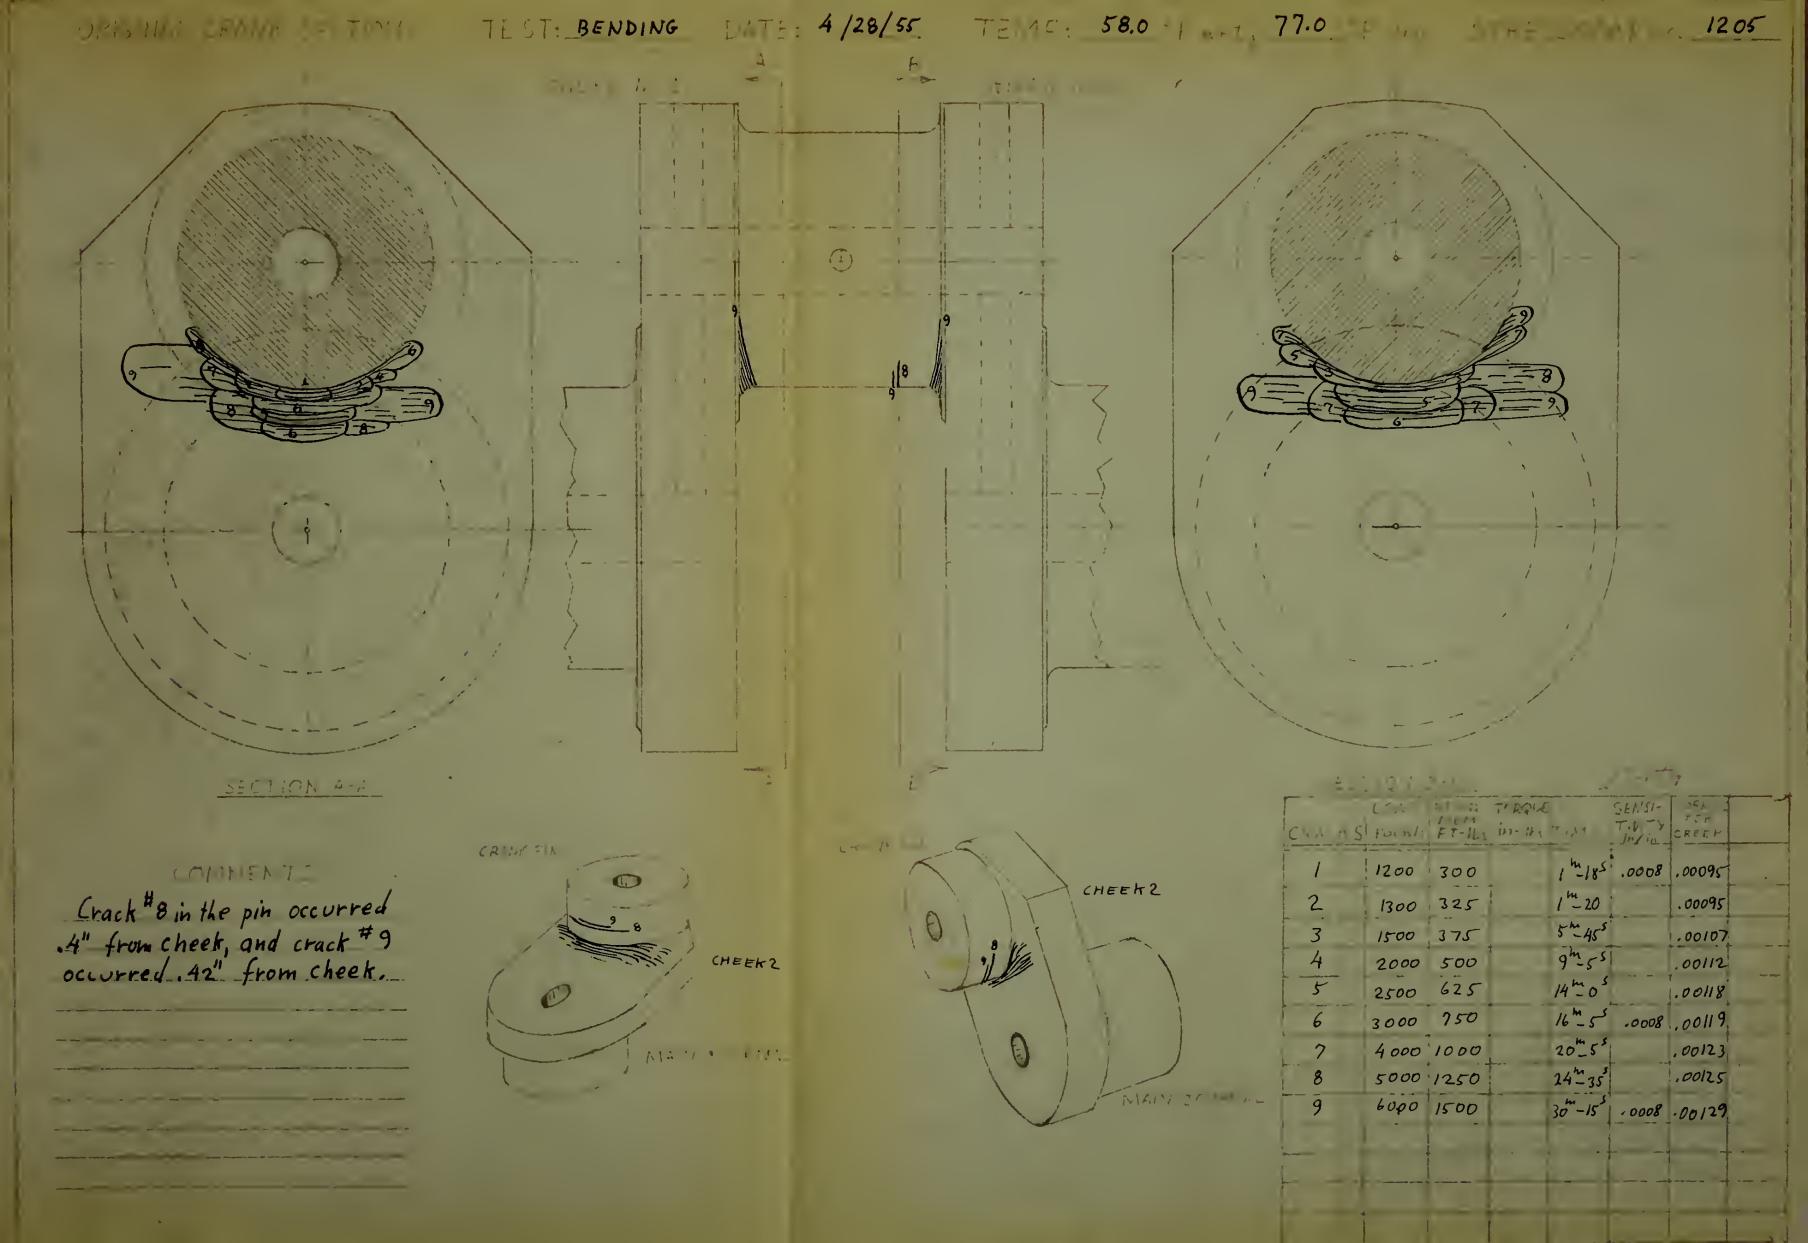
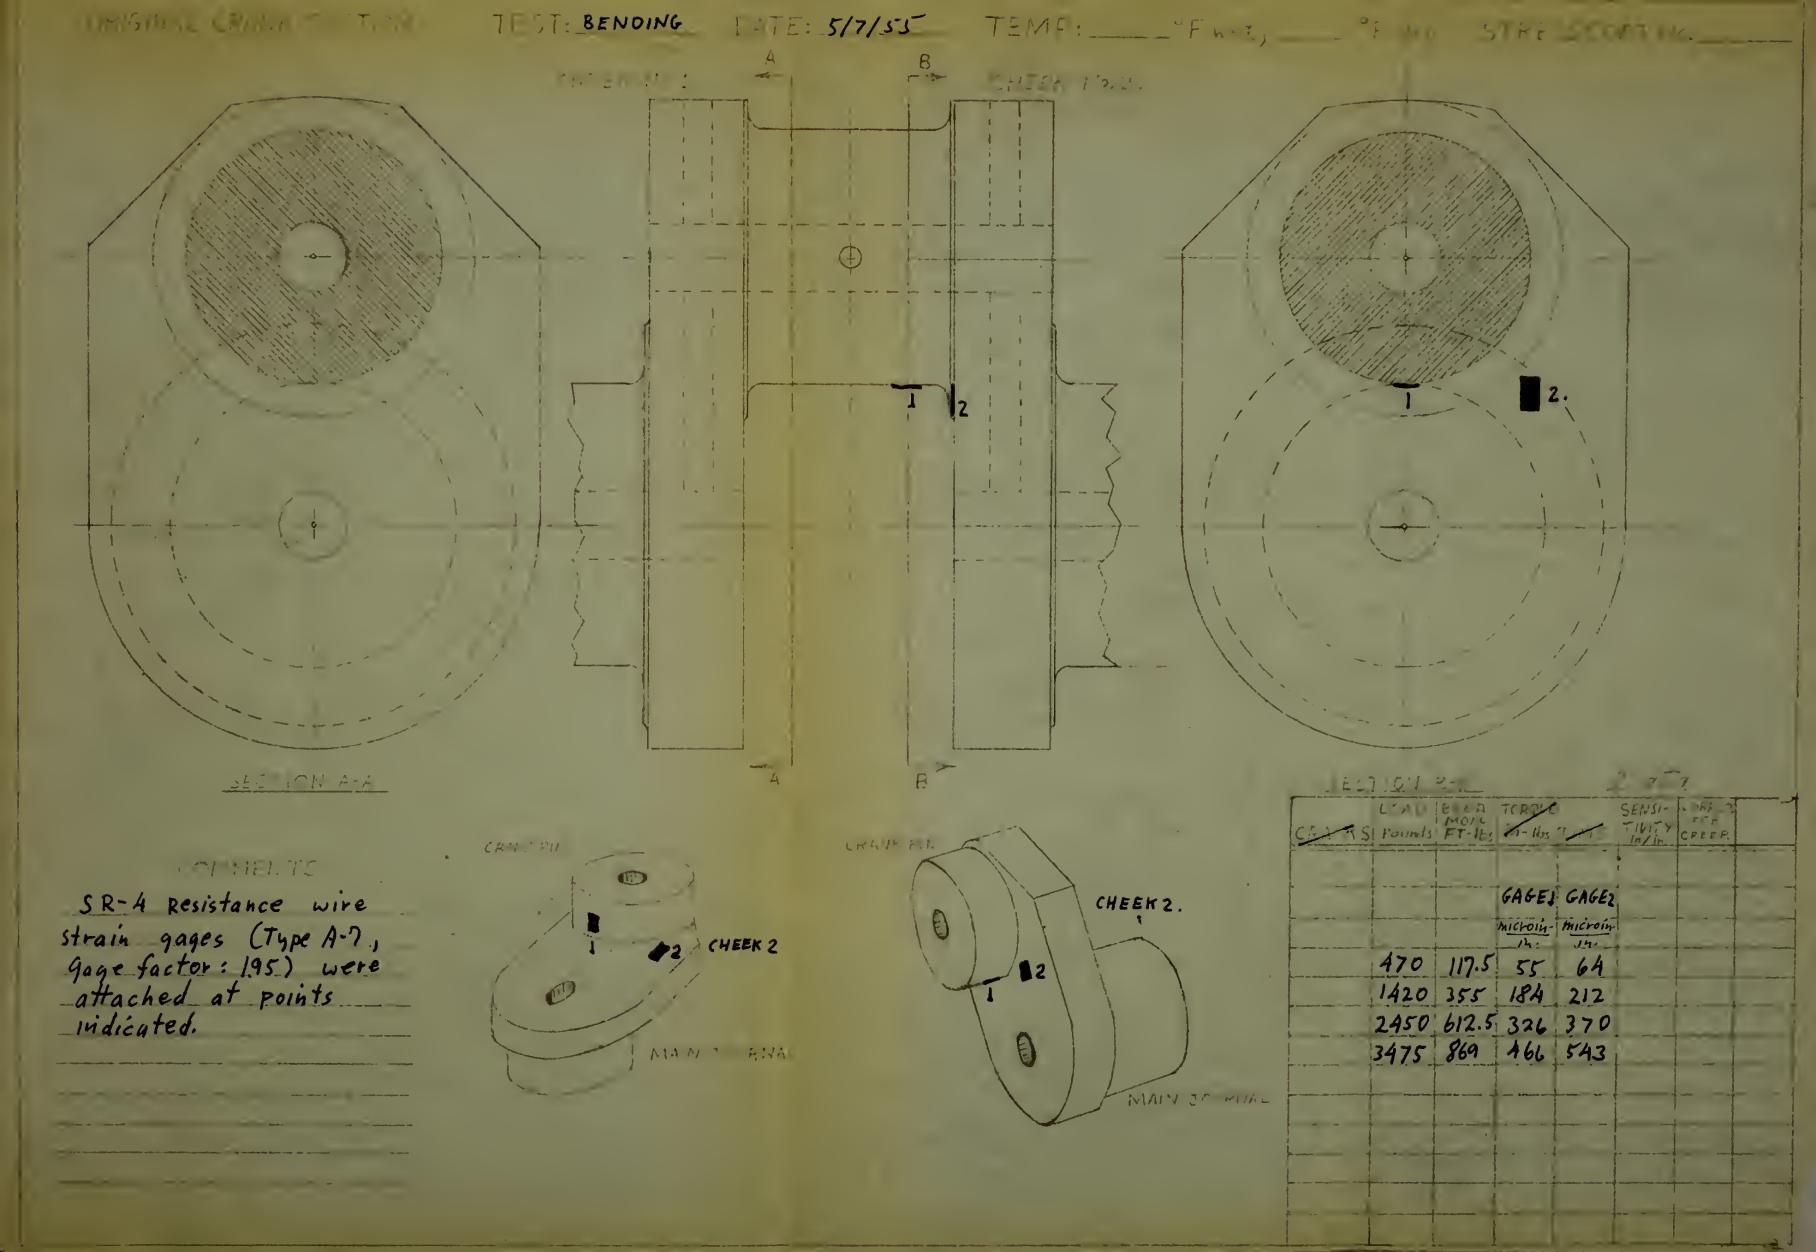
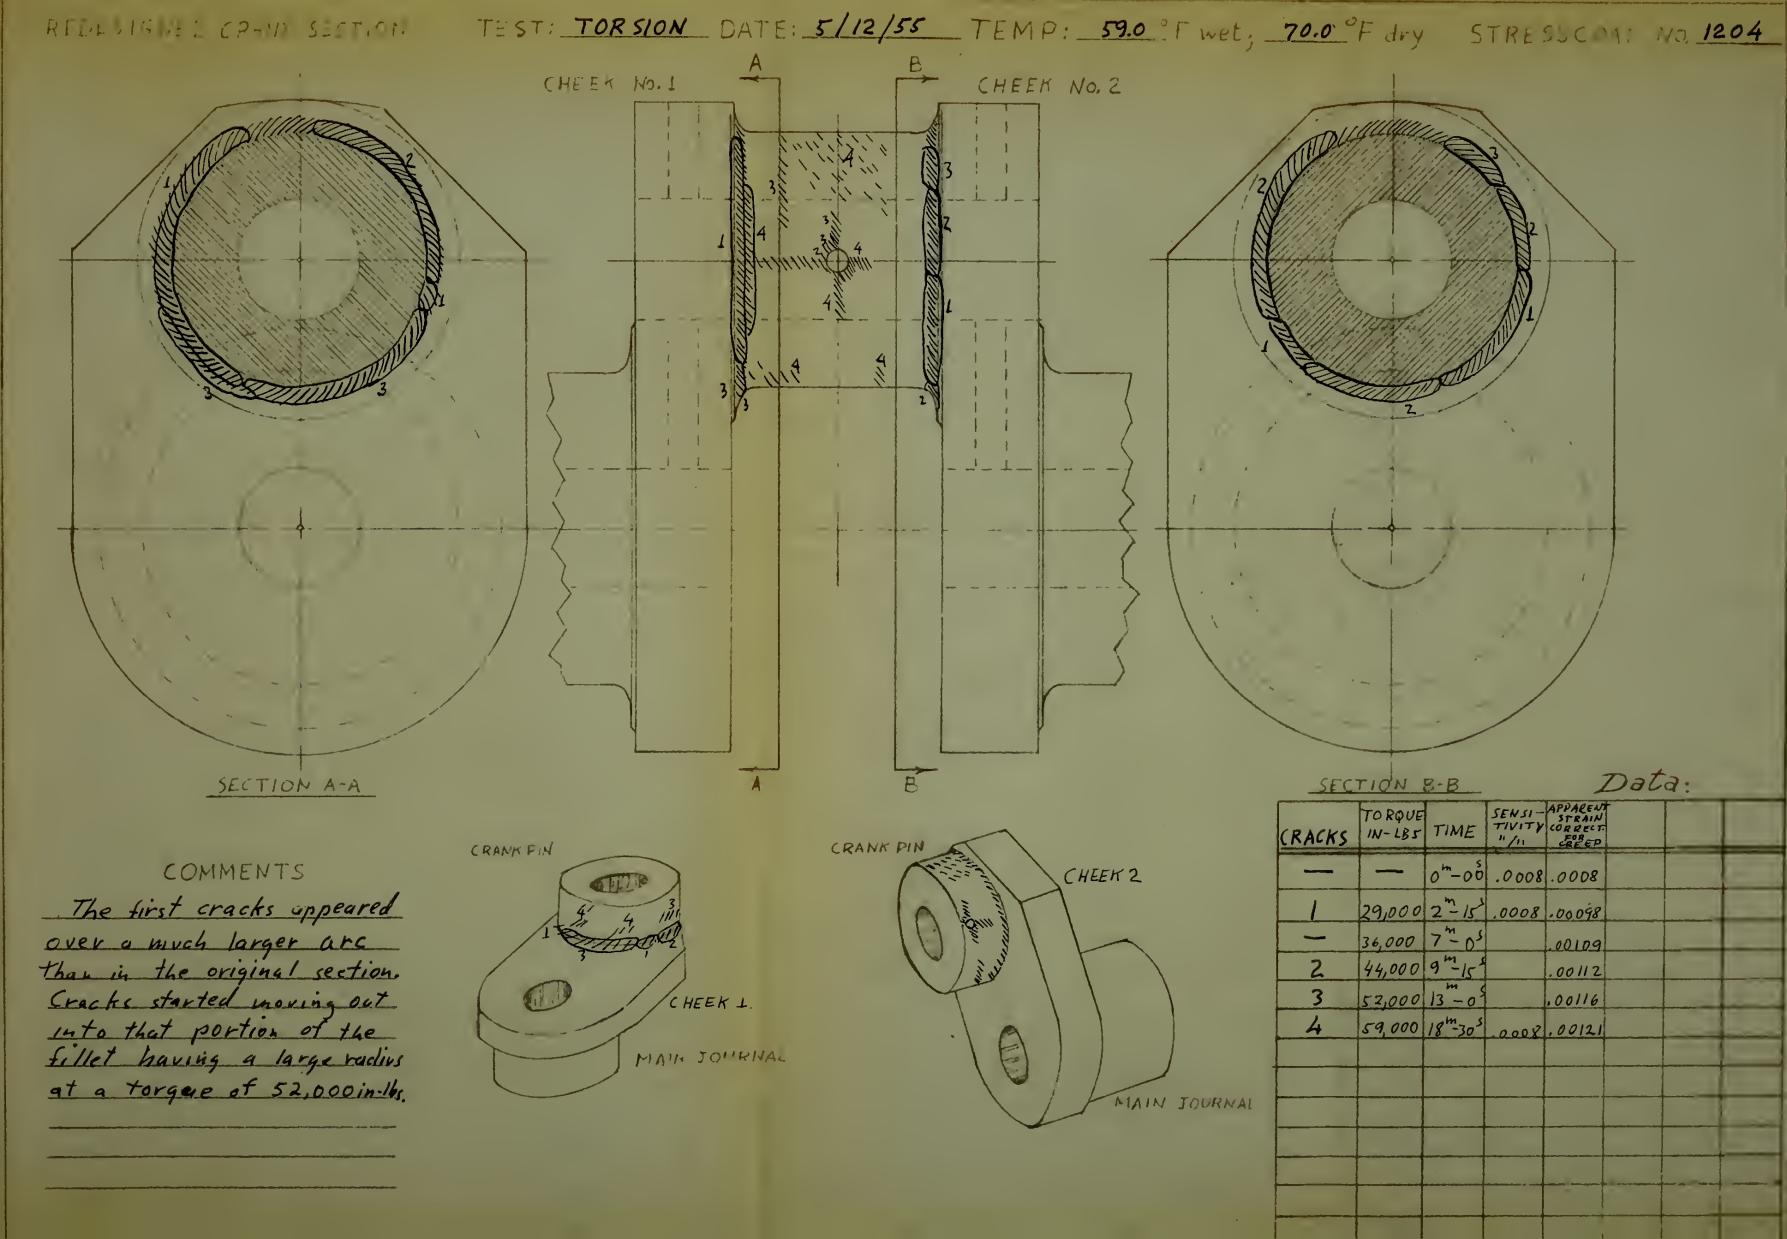
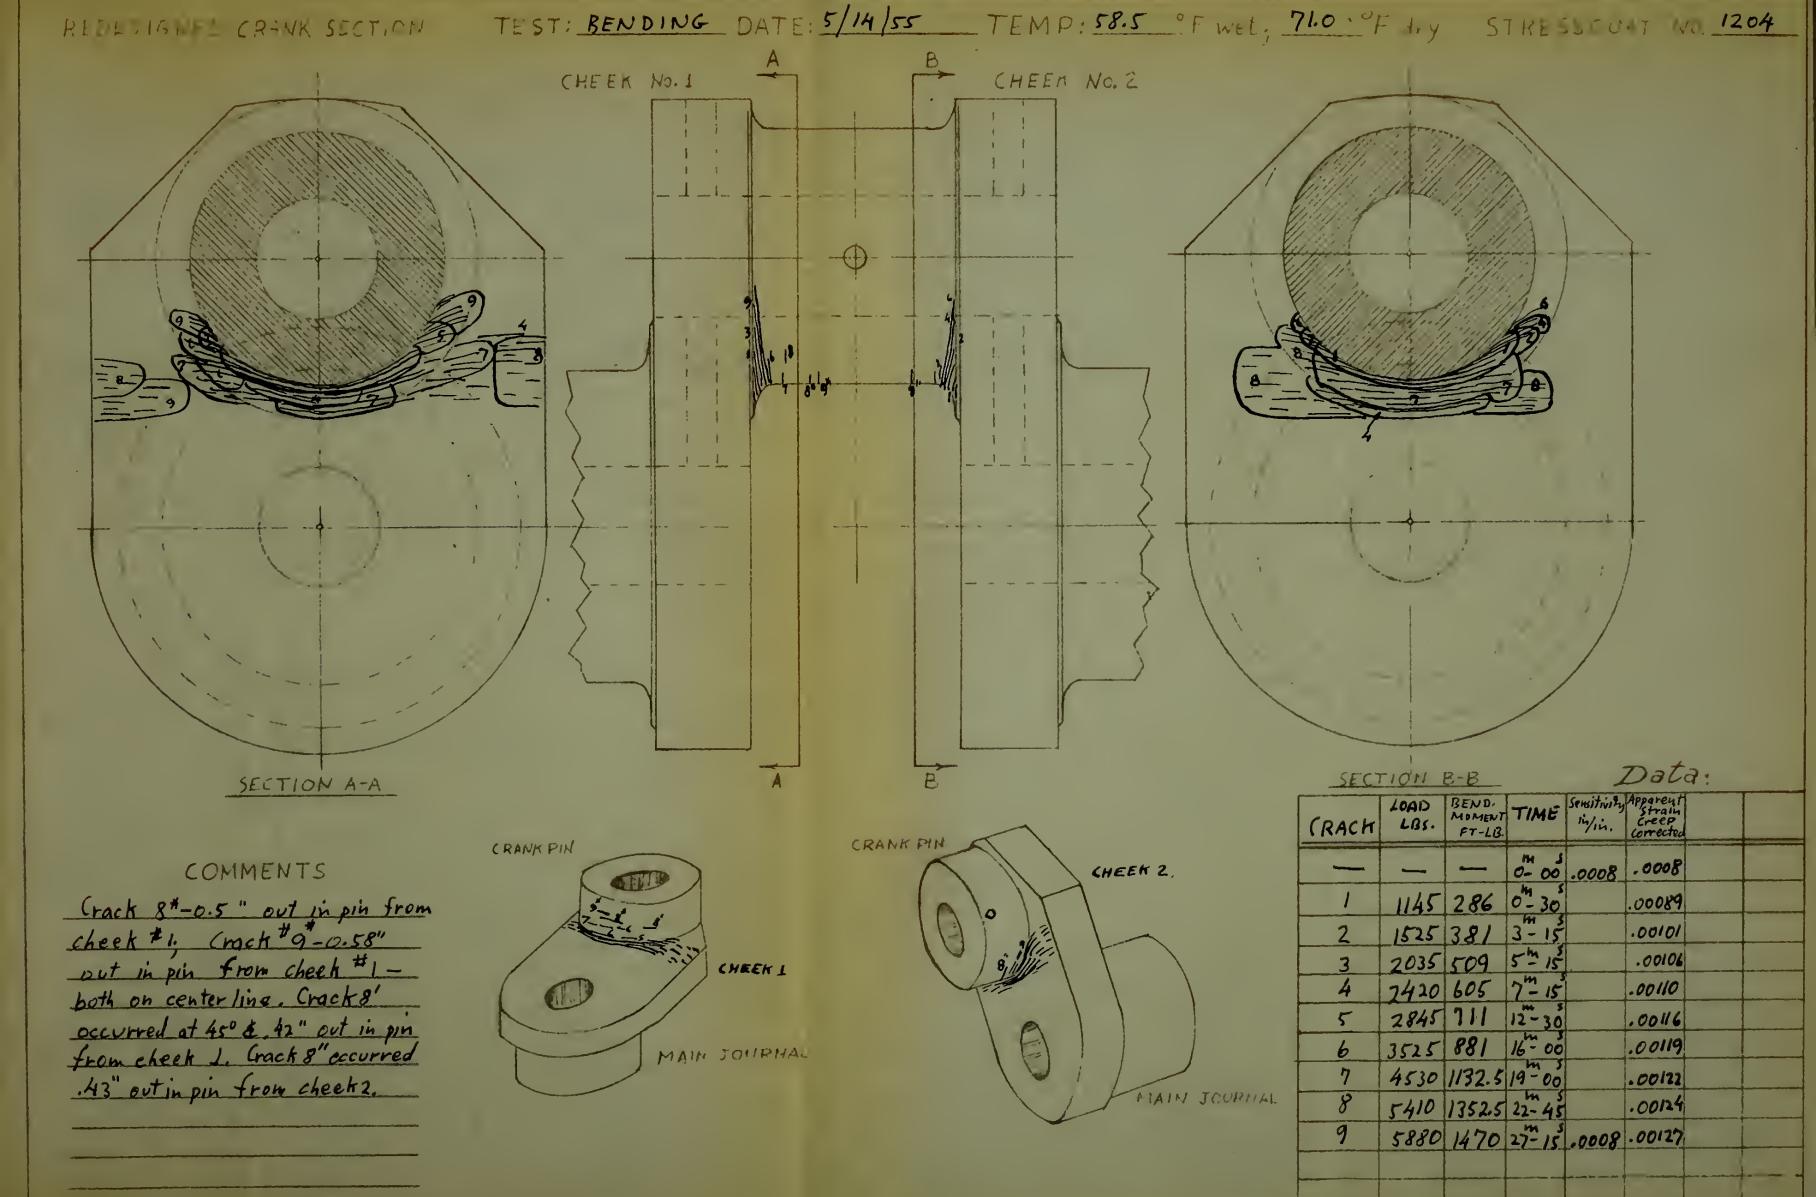
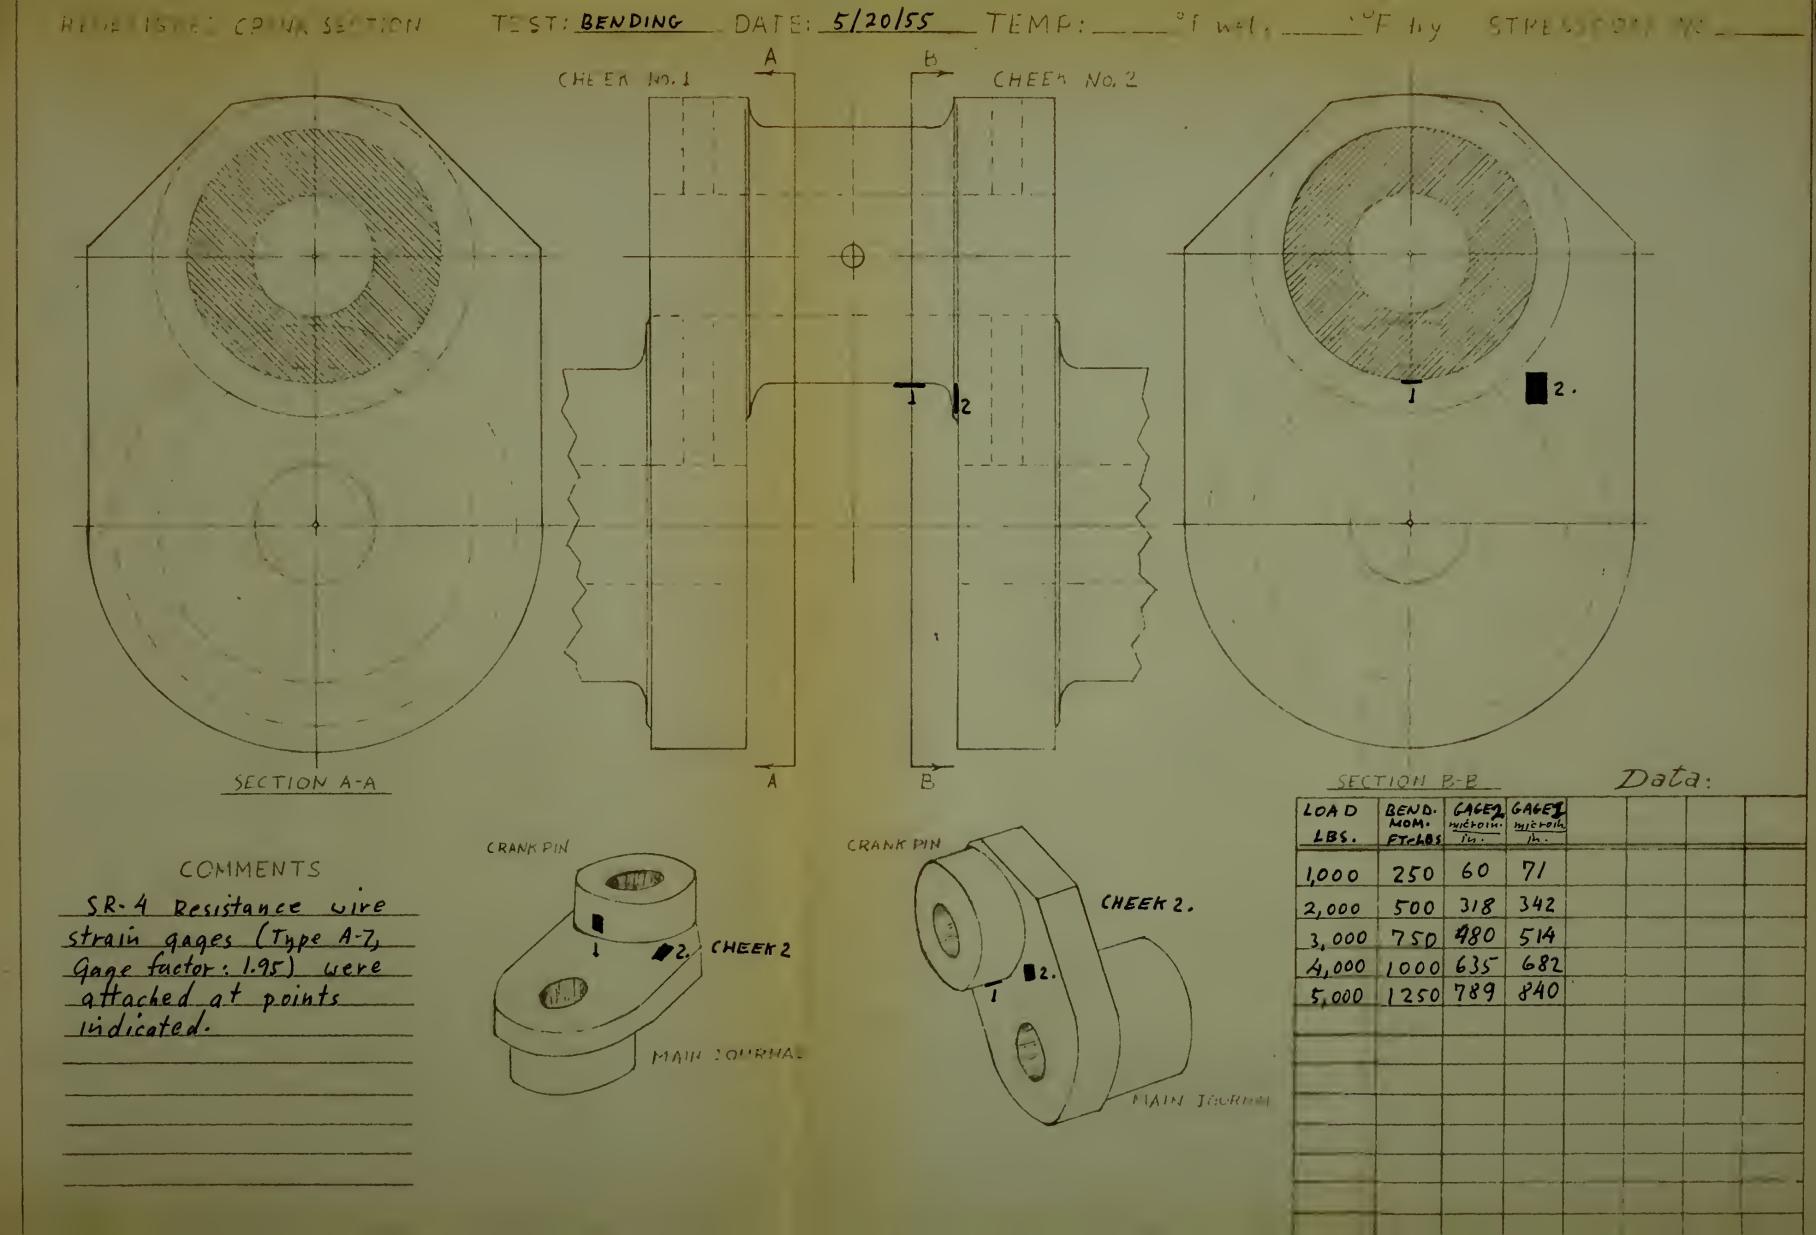
Eleven tests employing Stresscoat, other than those in Figures 14 through 20, were made to obtain the correct experimental technique.
